SUSQUEHANNA RIVER BASIN
KETTLE CREEK, BLAIR COUNTY
PENNSYLVANIA

POTTSGROVE DAM
NDI I.D. No. PA - 00527
PENNDER I.D. No. 7 - 19

PHASE I INSPECTION REPORT
NATIONAL DAM INSPECTION PROGRAM

PREPARED BY
GAI CONSULTANTS, INC.
570 BEATTY ROAD
MONROEVILLE, PENNSYLVANIA 15146

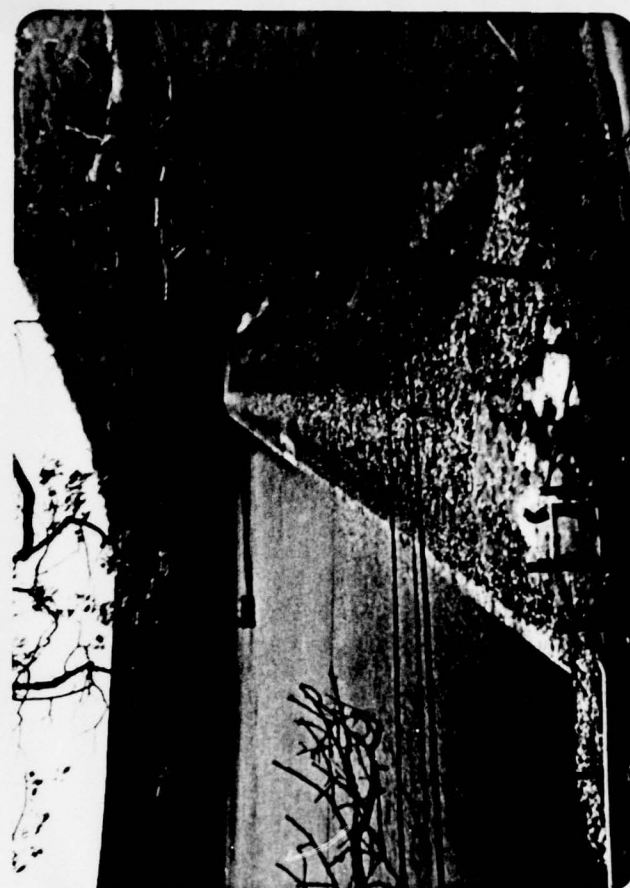
PHOTOGRAPH 12 Overview of upstream Brush Mountain Dam as viewed from the right abutment.
